Hochschule für Technik
und Wirtschaft Berlin

University of Applied Sciences

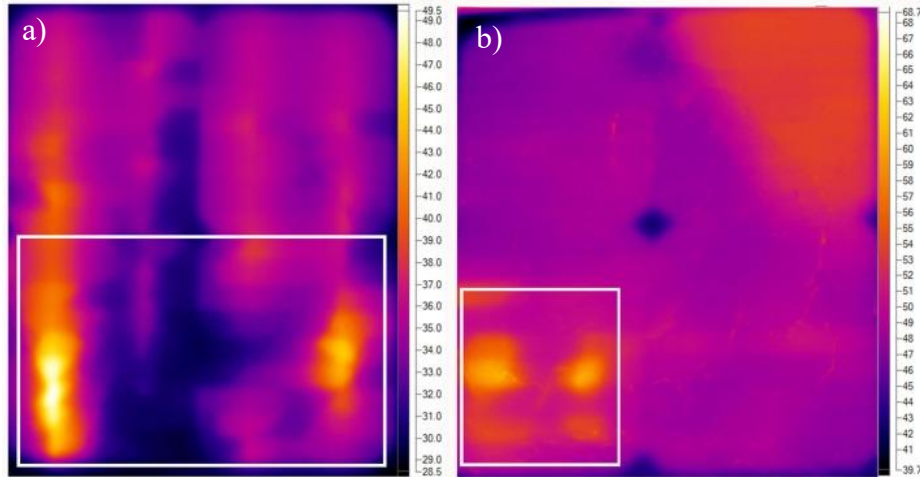
Figure 2-4: IR images of module in defective condition a) indoor, and b) outdoor. [51]

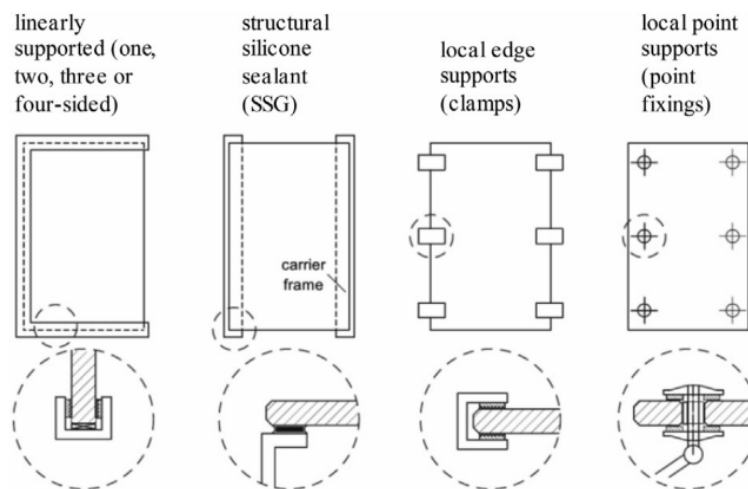
Figure 3-1: Common support types for glazing elements. [53]

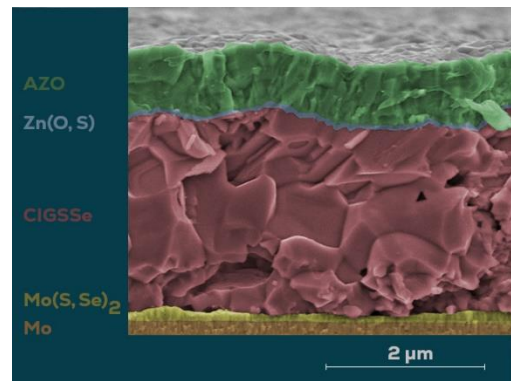
Figure 3-2: Construction of a CIGS solar cell on a microscopic scale [59].

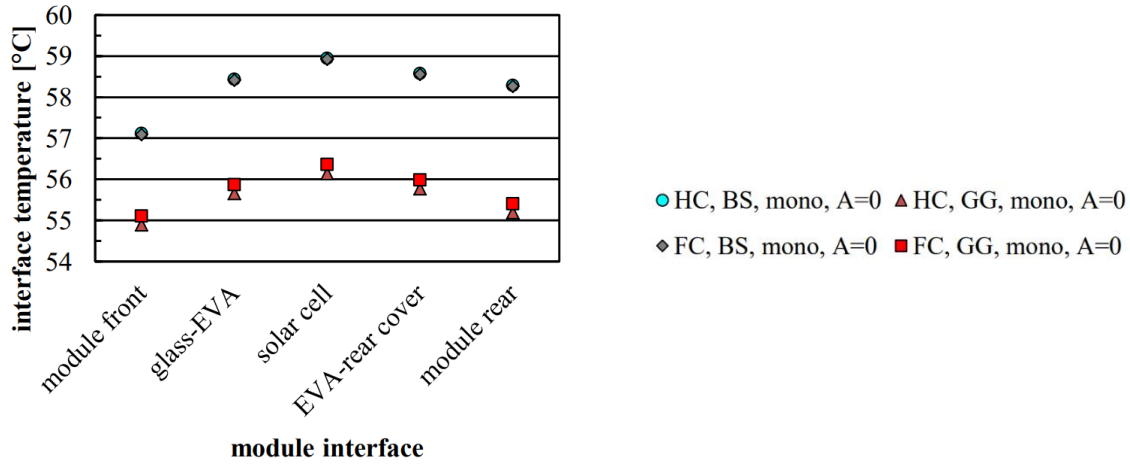
Figure 4-4: Layer temperature in different module setups. [75]

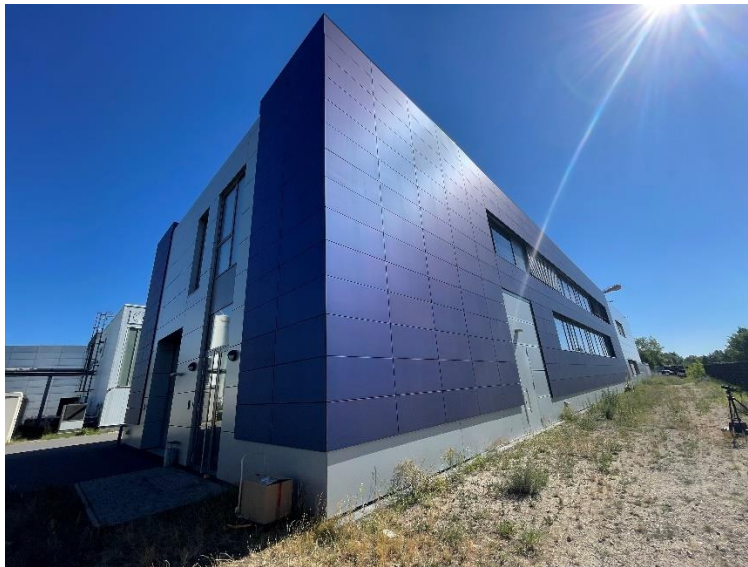
Figure 5-1: HZB Living Lab in Adlershof, Berlin from the southwest corner of the building during morning hours.

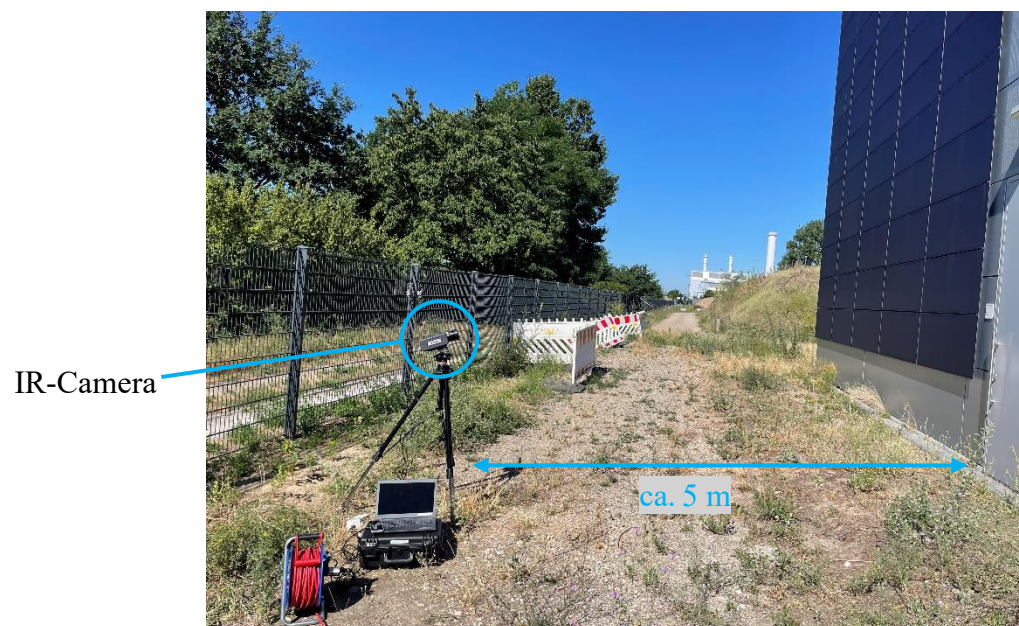
Figure 5-6: Measurement setup for the south facade.

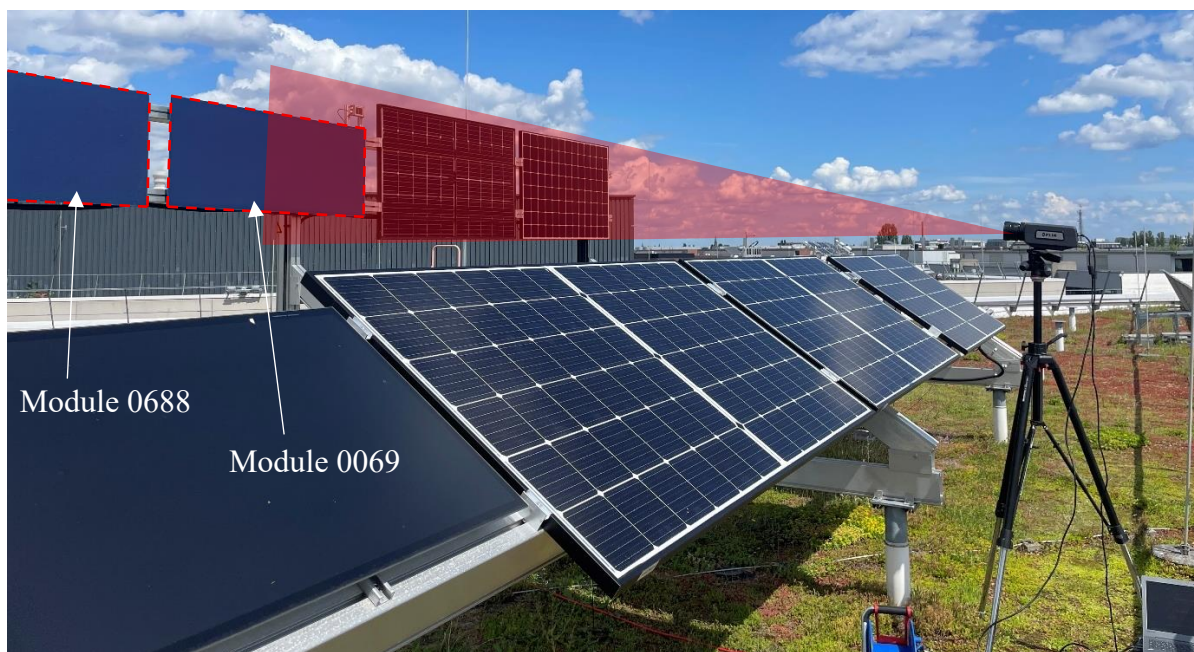
Figure 5-7: Measurement setup at the HZB outdoor performance laboratory measuring module 0069.

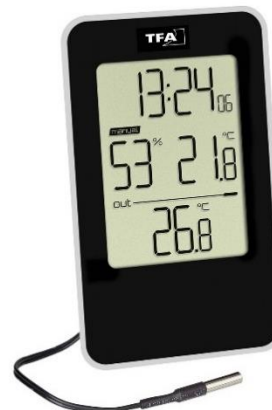
Figure 5-11: Digital thermo-hygrometer 30.5048 from TFA-Dostmann.[103]

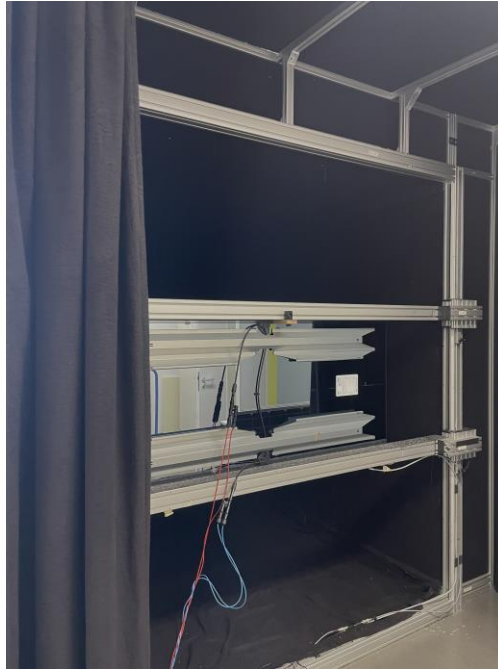
Figure 5-12: Construction of the module in the dark room of the flasher at HTW Berlin before closing the curtains.

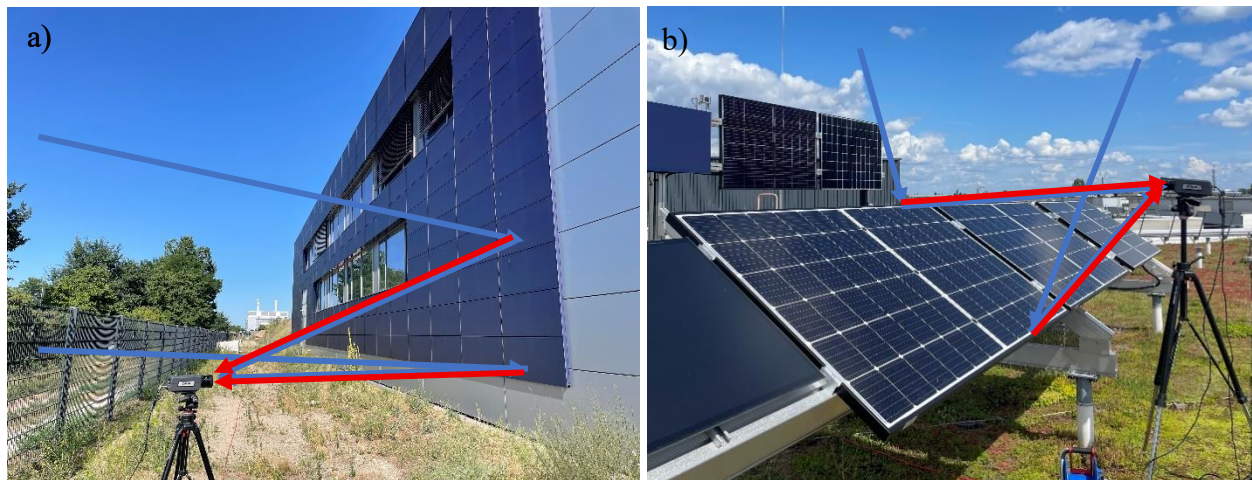
Figure 6-1: Relevance of the vertical orientation of most facade modules for IR measurement, b) facade modules with reflection of the horizon in comparison to a) 34°-angled modules with reflection of the (ideally cloudless) zenith, where the blue arrows represent the reflected ambient radiation and the red arrows represent the actual module radiation.

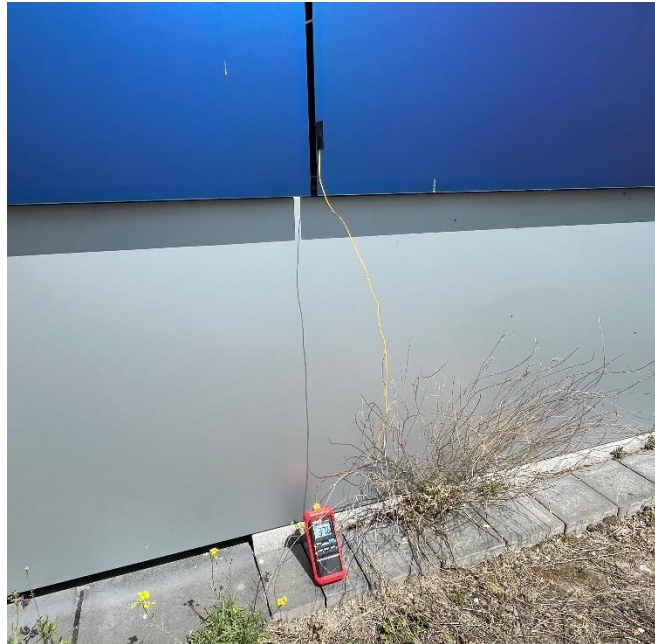
Figure 6-2: Thermocouple setup on the inactive area of the module.

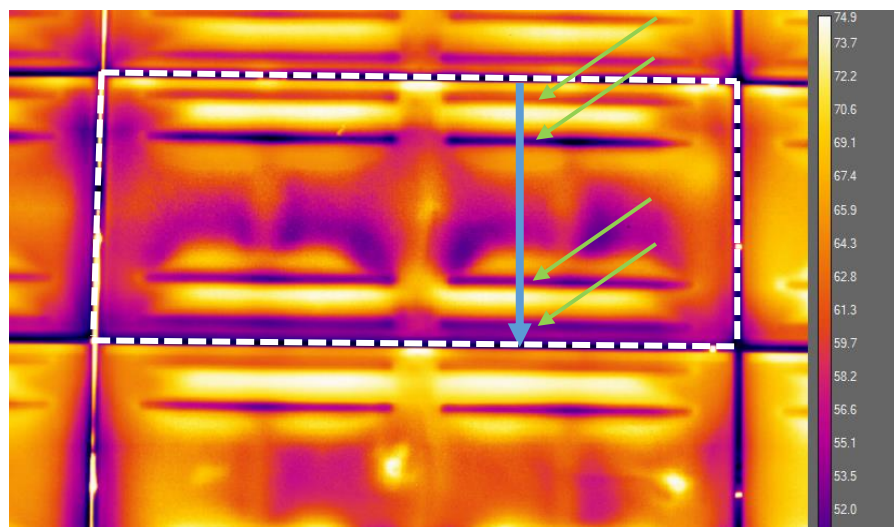
Figure 7-1: IR picture of module P13 along the south facade while P13 is marked with a white dashed outline and the line scan analyzed in Figure 7-2 marked light blue.

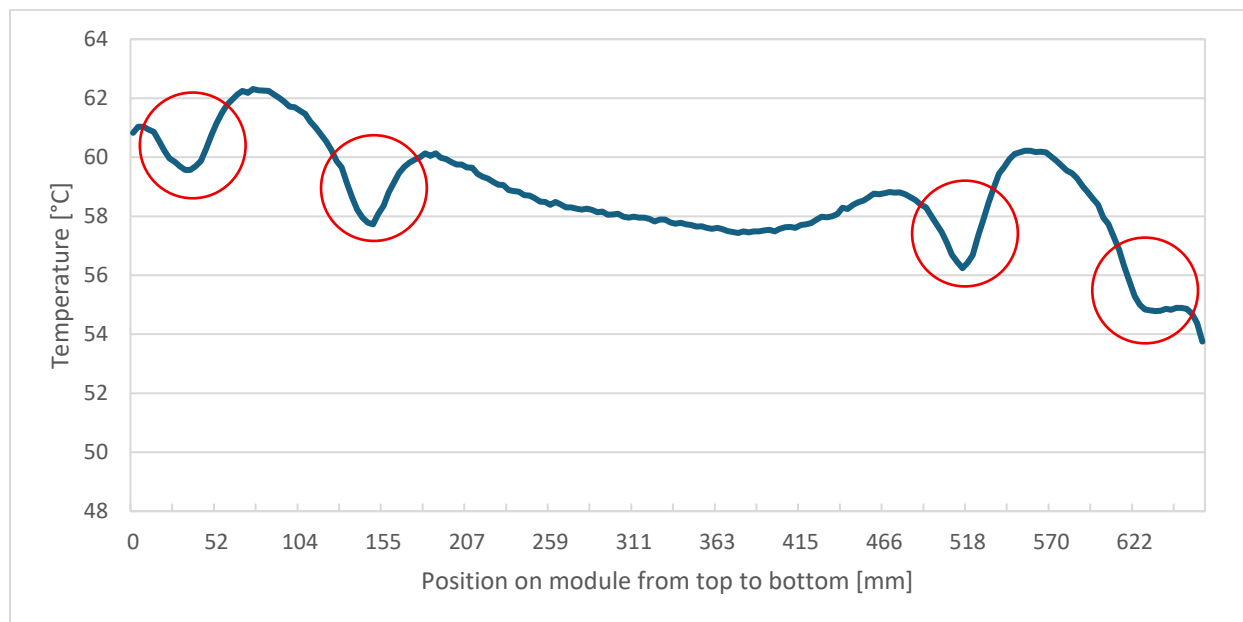
Figure 7-2: Temperature course from top to bottom of module P13.

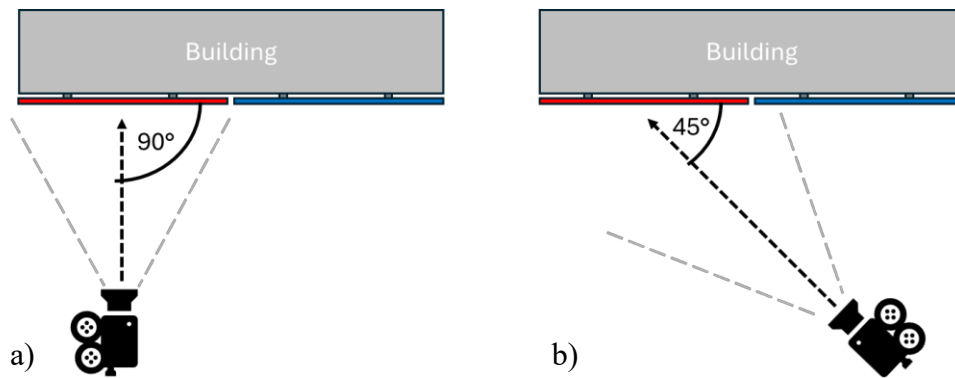
Figure 7-3: Top view illustration of the measurement setup with the module being recorded by the IR camera positioned on the left side and marked red, a) being the setup as in Figure 7-5, and b) being the setup as in Figure 7-6.

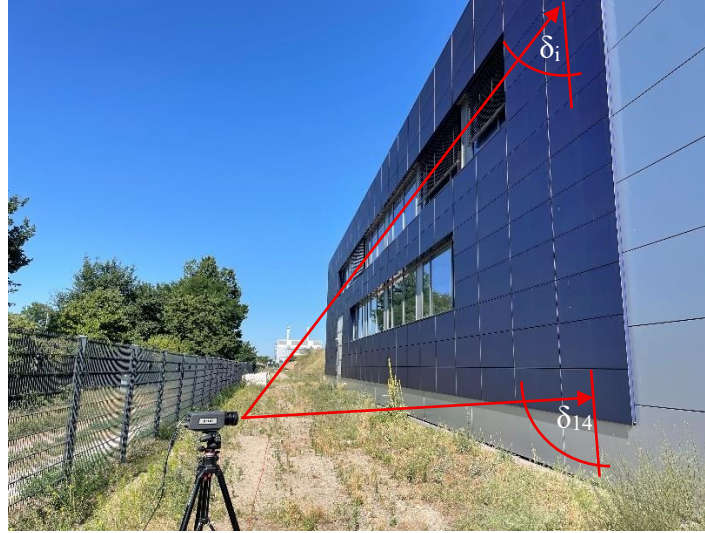
Figure 7-4: Visualization of camera angle changing according to height of module position, δ represents the angle of the camera to the plane of the module, and the index i indicating the position of a module in a column.

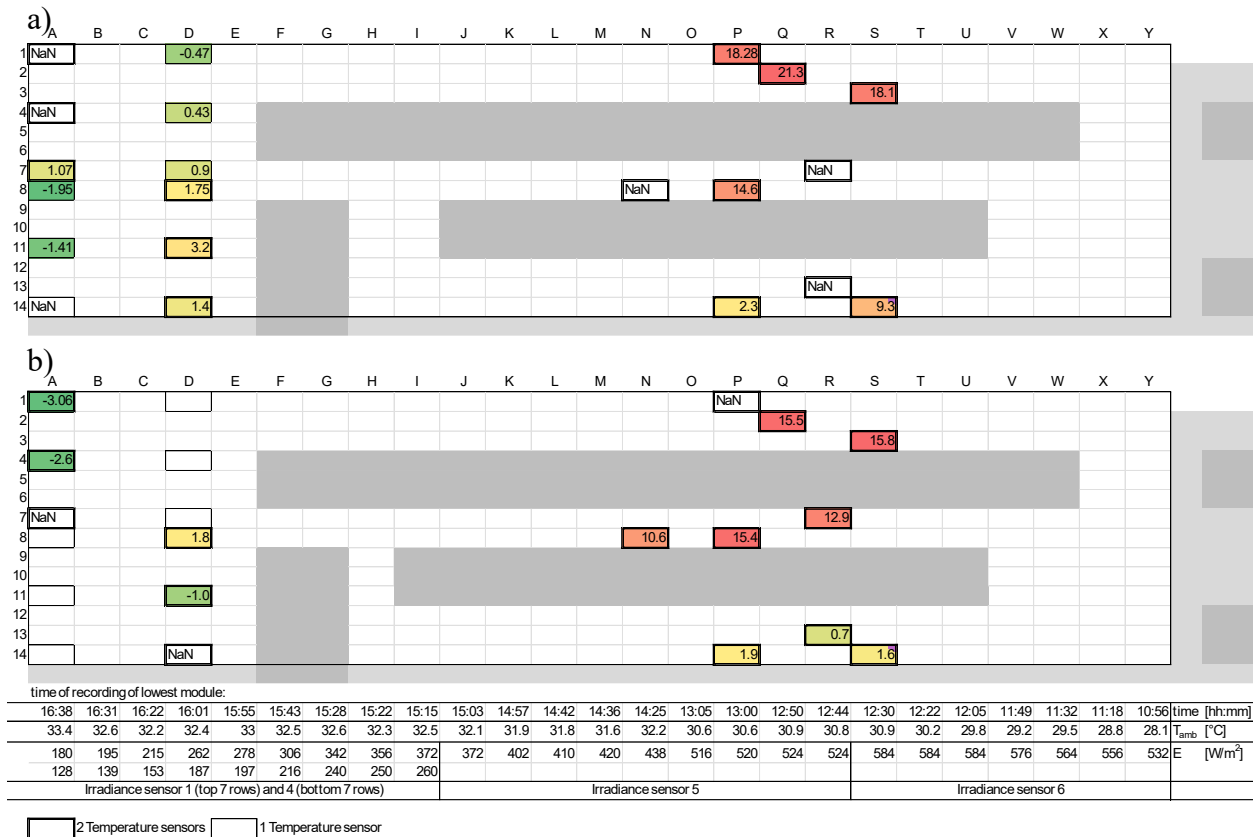
Figure 7-8: Temperature difference (ΔT) of mean temperature measured by IR camera as in Figure 7-5 and measured by temperature sensor on module backsides of selected modules at the same time, a) with the sensor placed in the center of the module, and b) with the sensor placed at the edge of the module.

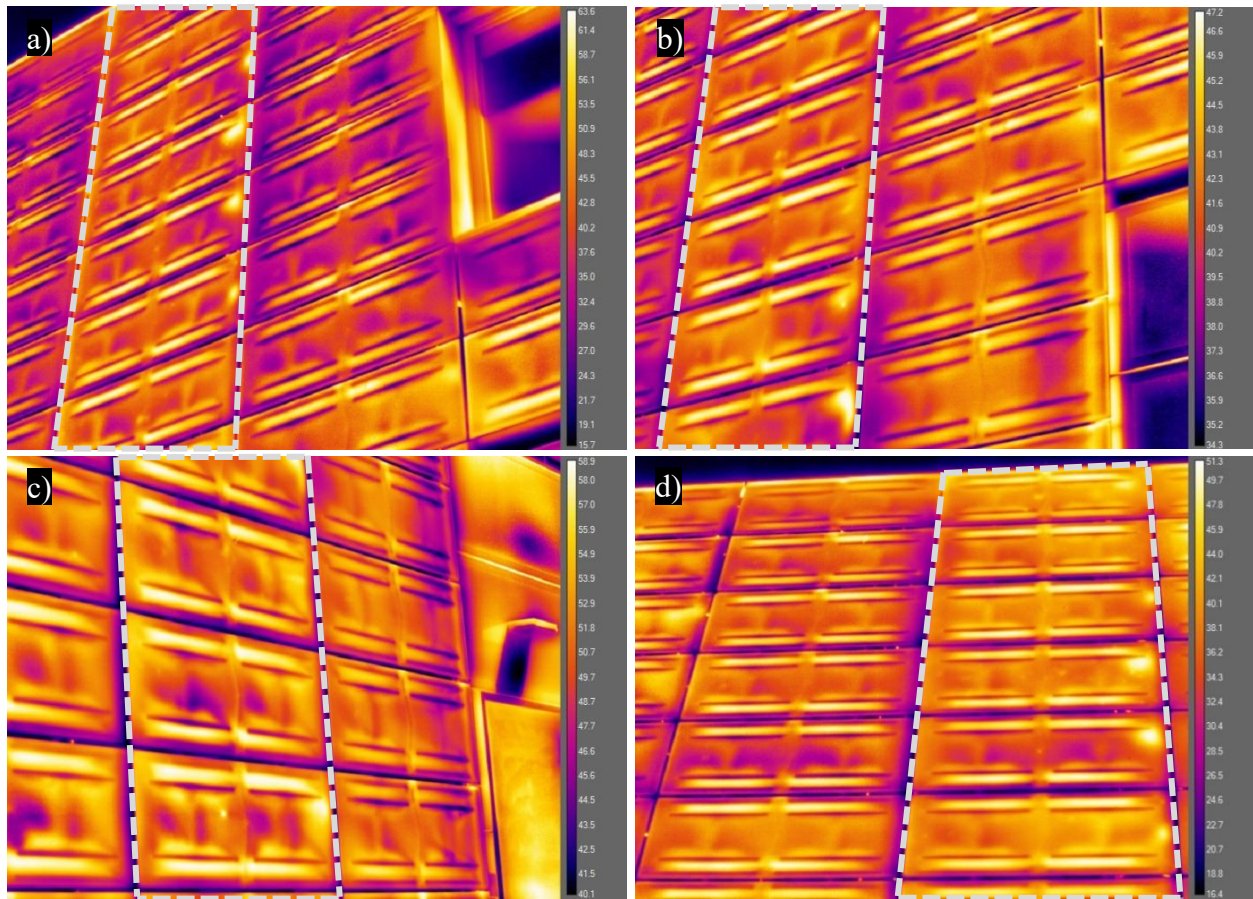
Figure 7-10: IR recordings of open-circuit strings marked by grey dashed border, a) showing modules D2 to D8 from the right, b) showing modules D6 to D10 from the right, c) showing modules D10 to D13 from the left, and d) showing modules D1 to D7 from the front.

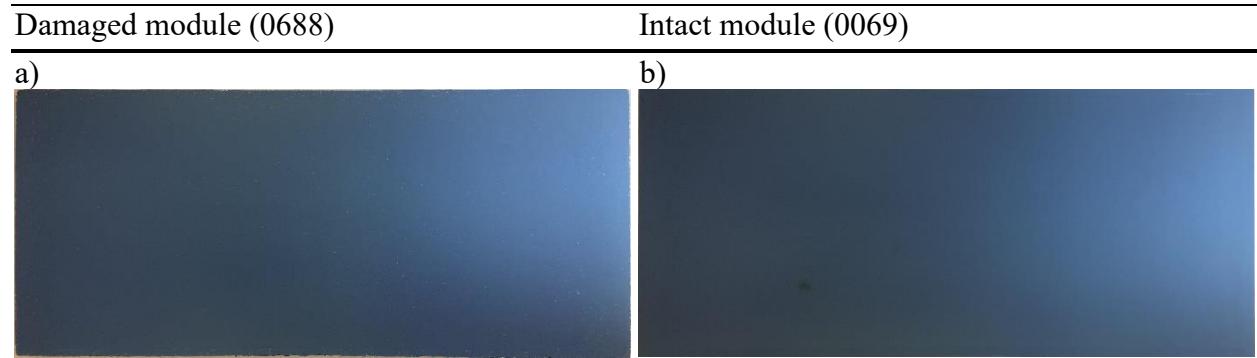
Figure 7-12: Image of a) a damaged module 0688, and b) an intact module 0069 in an indoor environment with incident irradiation coming from the right.

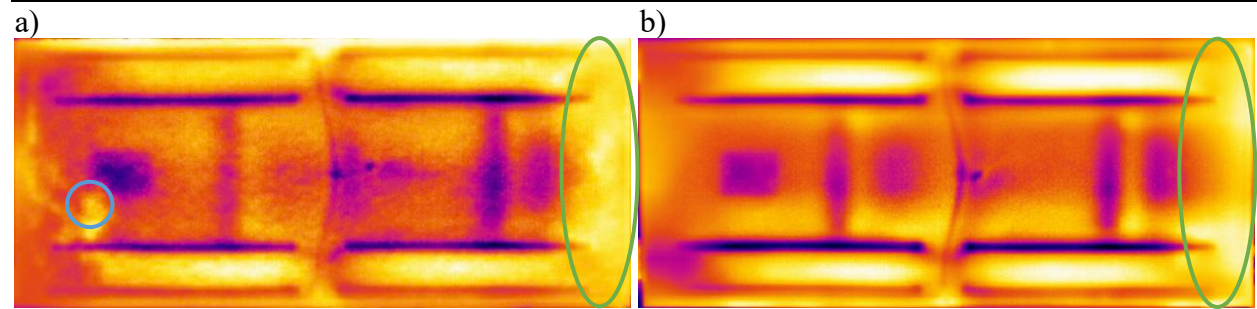
Figure 7-13: a) IR recording of module 0688 on 30.07.25 at 14:04, and b) IR recording of module 0069 on 30.07.25 at 13:50.

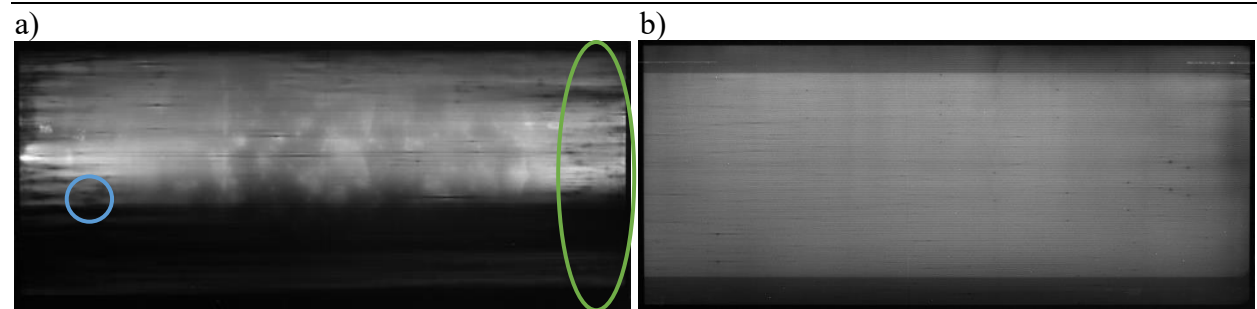
Figure 7-14: a) EL recording of a functioning module but with damaged front glass (module 0688), b) EL recording of an intact module (module 0069).

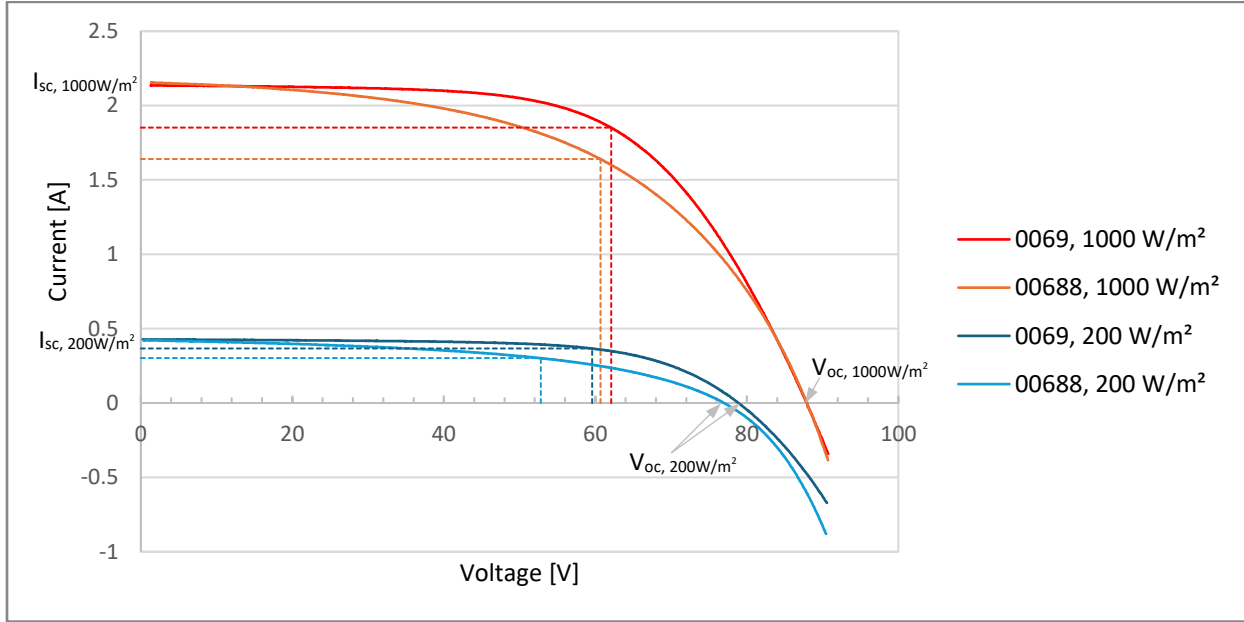
Figure 7-16: IV curves of both modules at irradiances of 1,000 W/m² and 200 W/m².

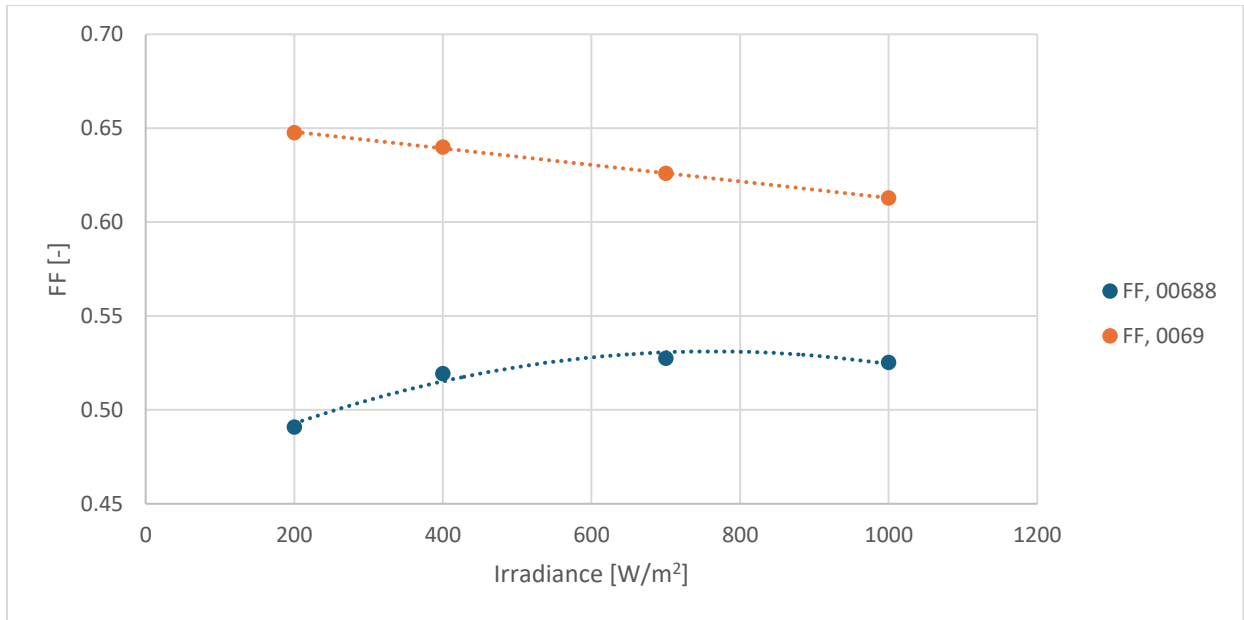
Figure 7-17: Development of fill factors across irradiance for module 0069 and module 0688.

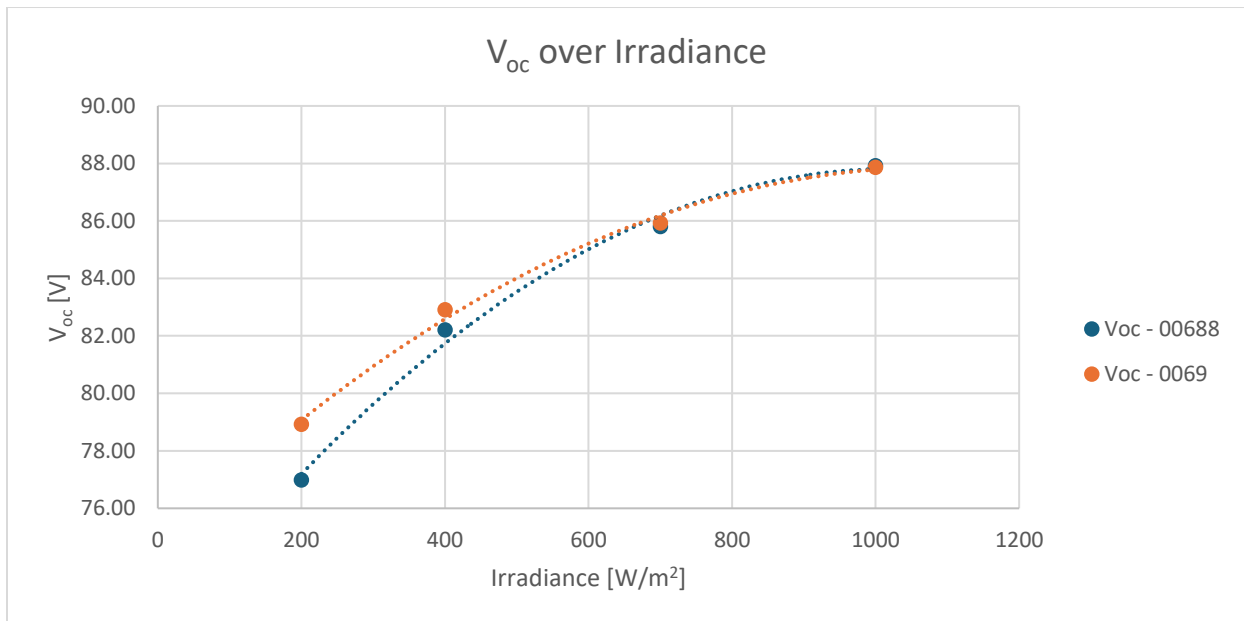
Figure 7-18: Development of V_{oc} across irradiance of module 0069 and module 0688.

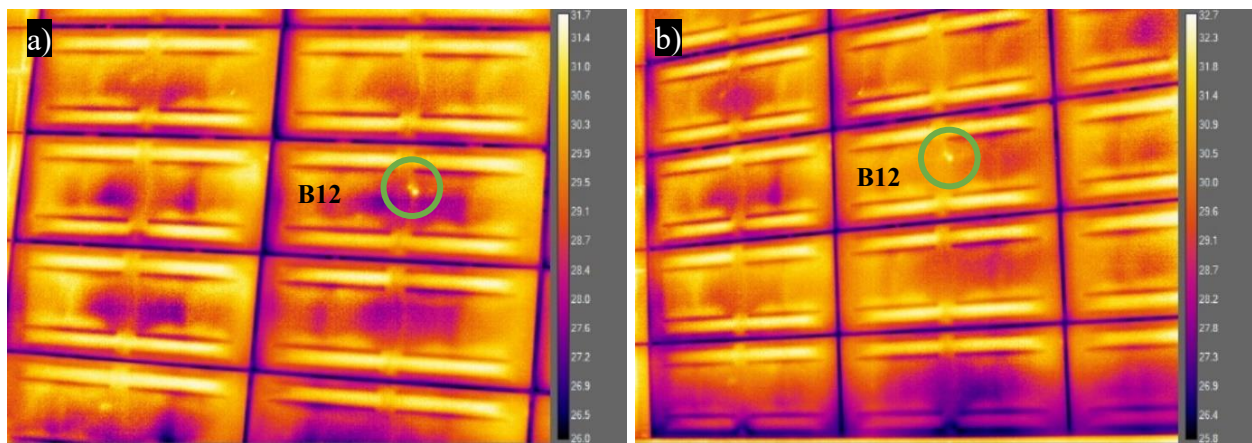
Figure 7-19: North facade with hotspot in module B12 circled green, measured on 20.06.25 a) at 16:41 and b) 16:21.

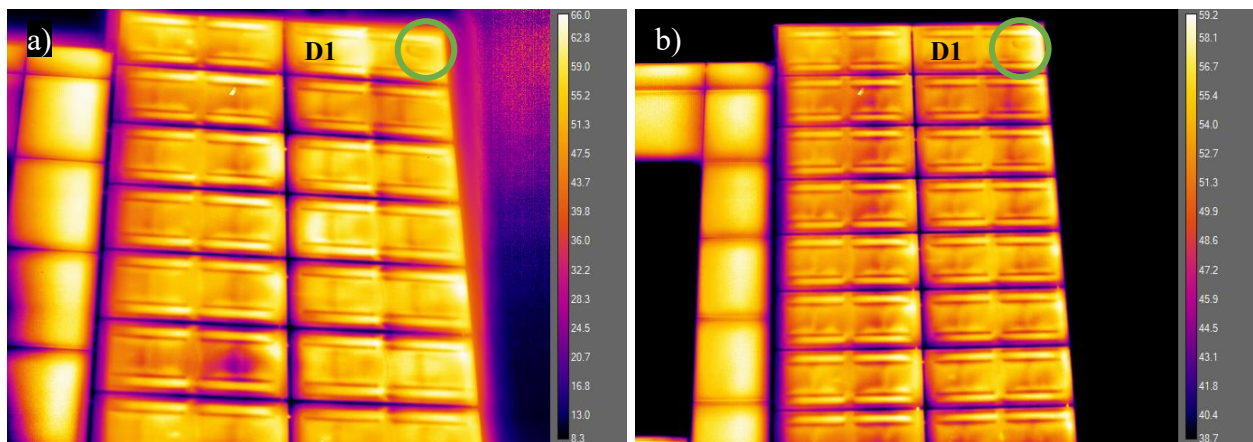
Figure 7-21: West facade crescent shaped cool area on module D1 measured on 20.06.25 a) at 15:50, and b) at 15:29.

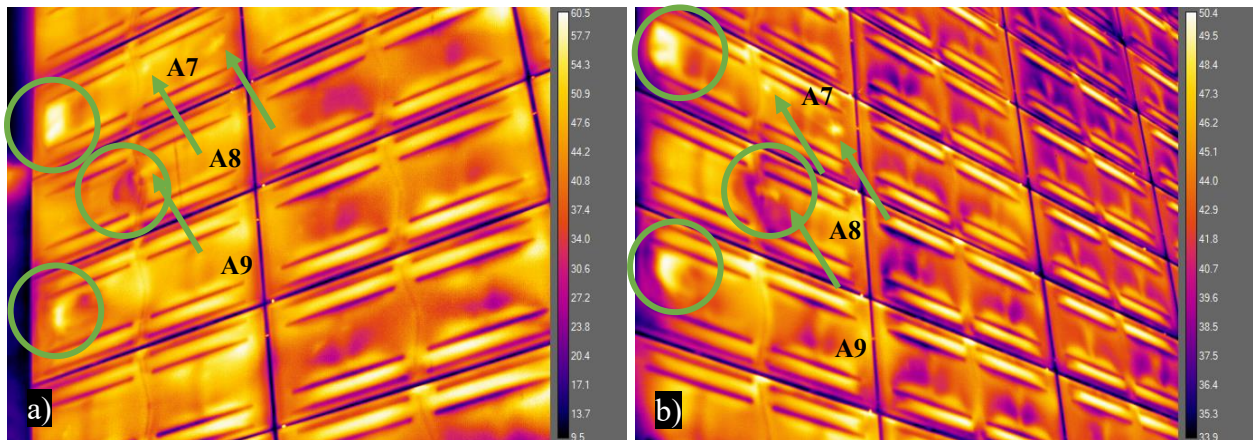
Figure 7-22: South facade with a hot and cold spot pattern along modules A7, A8 and A9, a) on 20.05.25 at 13:30, and b) 20.06.25 at 14:02.

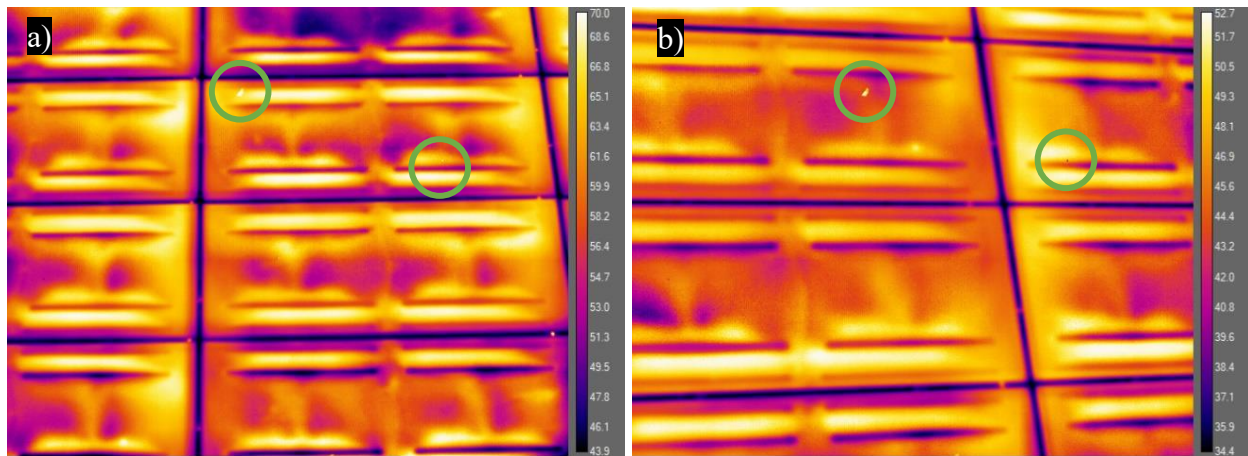
Figure 7-24: Effects of lens damage throughout the measurements recorded on different days circled green, a) on 20.05.25, and b) on 02.06.25.

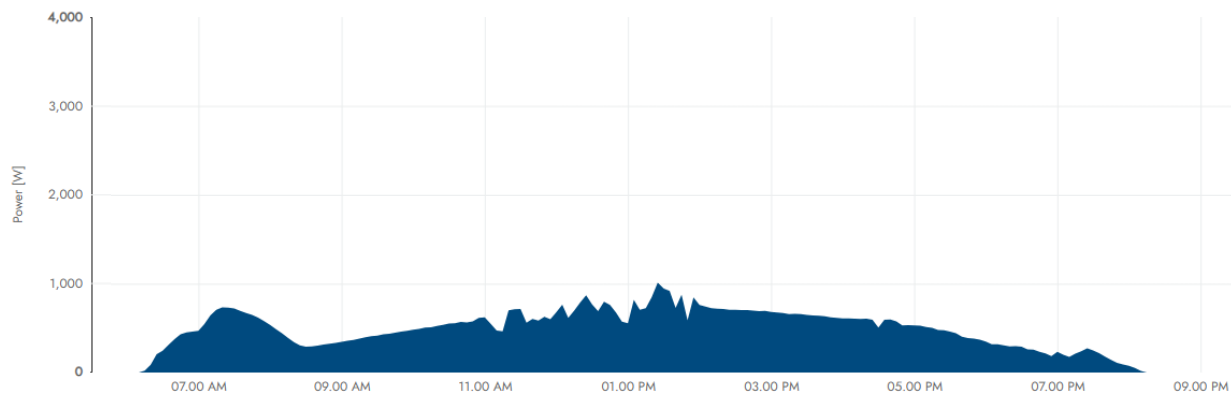
Figure 7-25: Power generated by the north facade on 09.08.25 – an exemplary sunny day. [124]

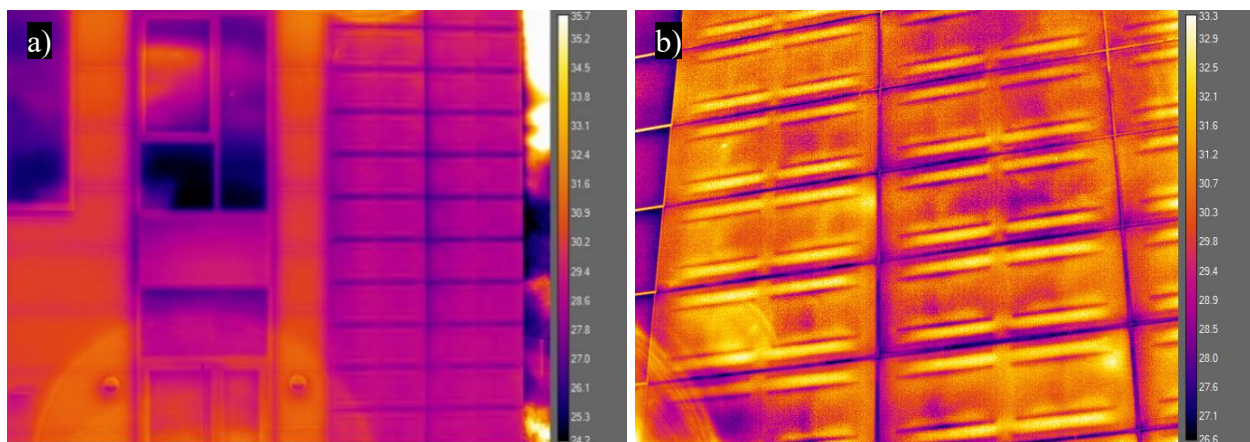
Figure 7-26: Bad positioning of the camera in reference to the sun's position causing reflection of the lens a) on the west facade during morning hours with AGC algorithm: PE on 02.06.25, b) on the north facade during early afternoon hours with AGC algorithm: APE on 20.06.25.

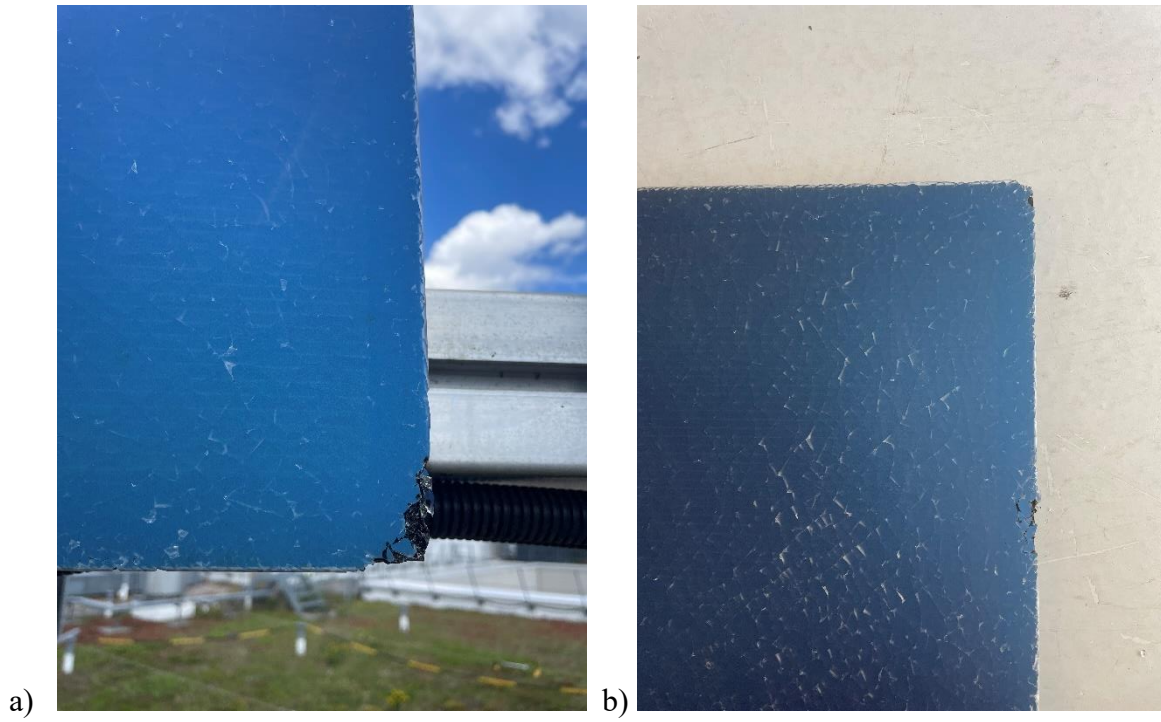
Figure 12-2: Close-up of damaged front glass in module 0688

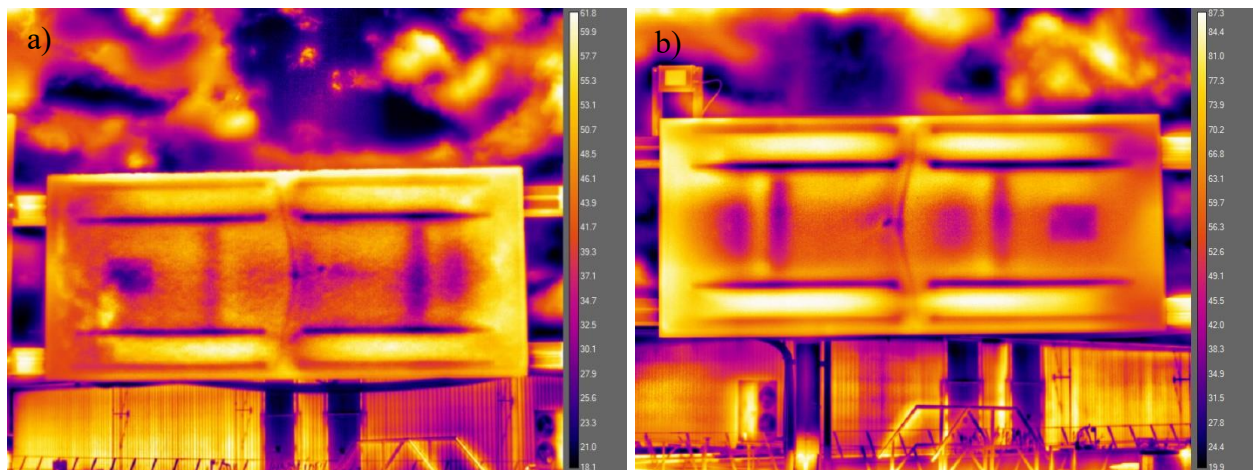
Figure 12-3: Entire IR recordings including temperature scale, a) IR recording of module 0688, b) mirrored IR recoding of module 0069
